DOT/FAA/AR-95/108

Characterization of Early Stages of Corrosion Fatigue in Aircraft Skin

February 1996

Final Report

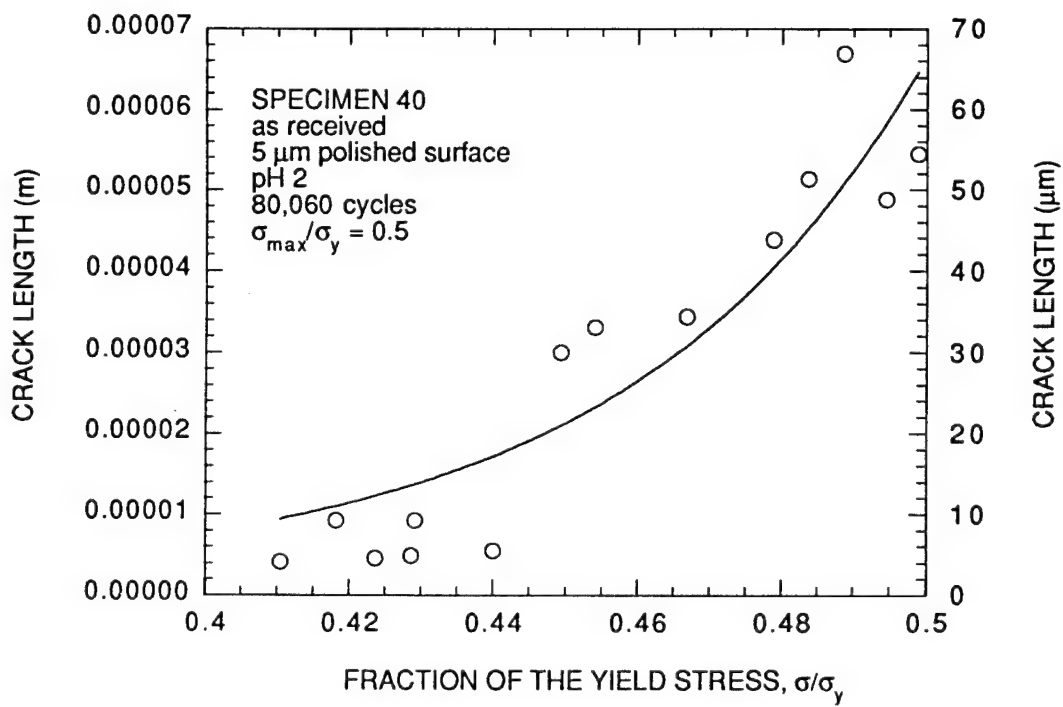
Figure A-26. Crack length data measurements and the least squares fit for Test 40.

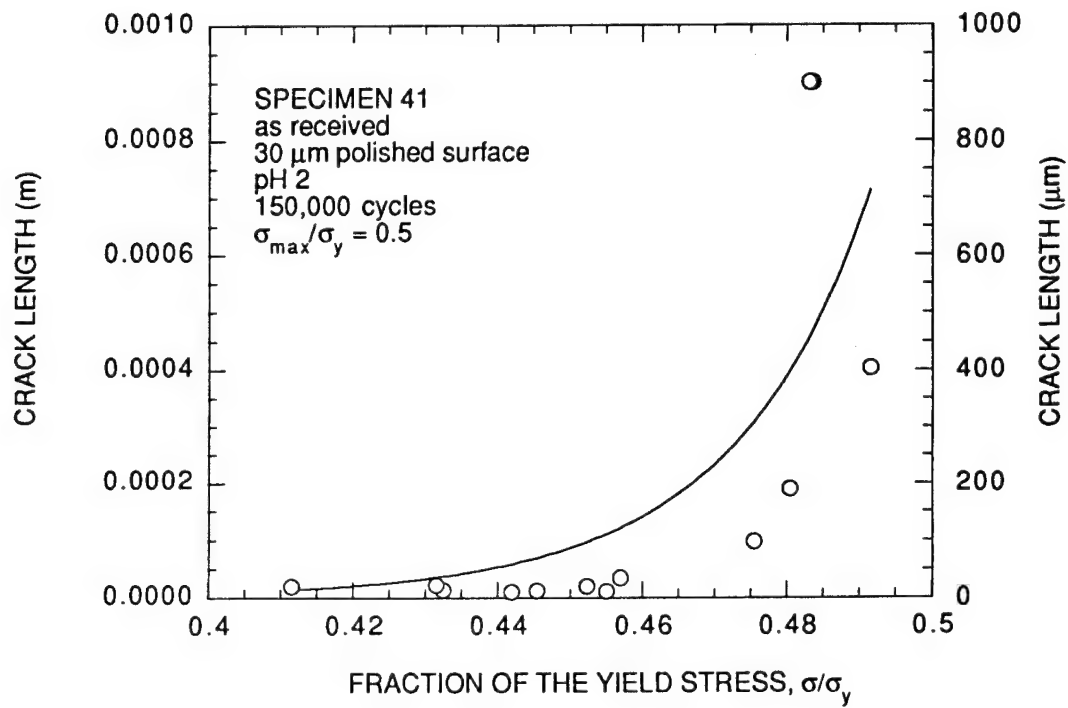
Figure A-27. Crack length data measurements and the least squares fit for Test 41.

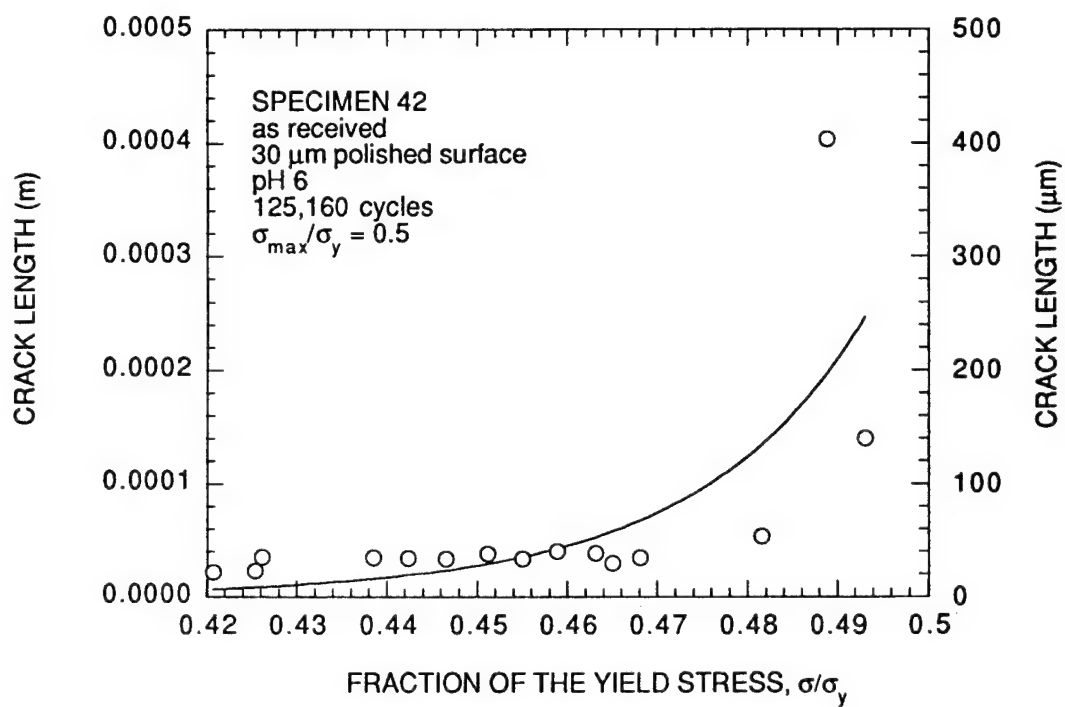
Figure A-28. Crack length data measurements and the least squares fit for Test 42.

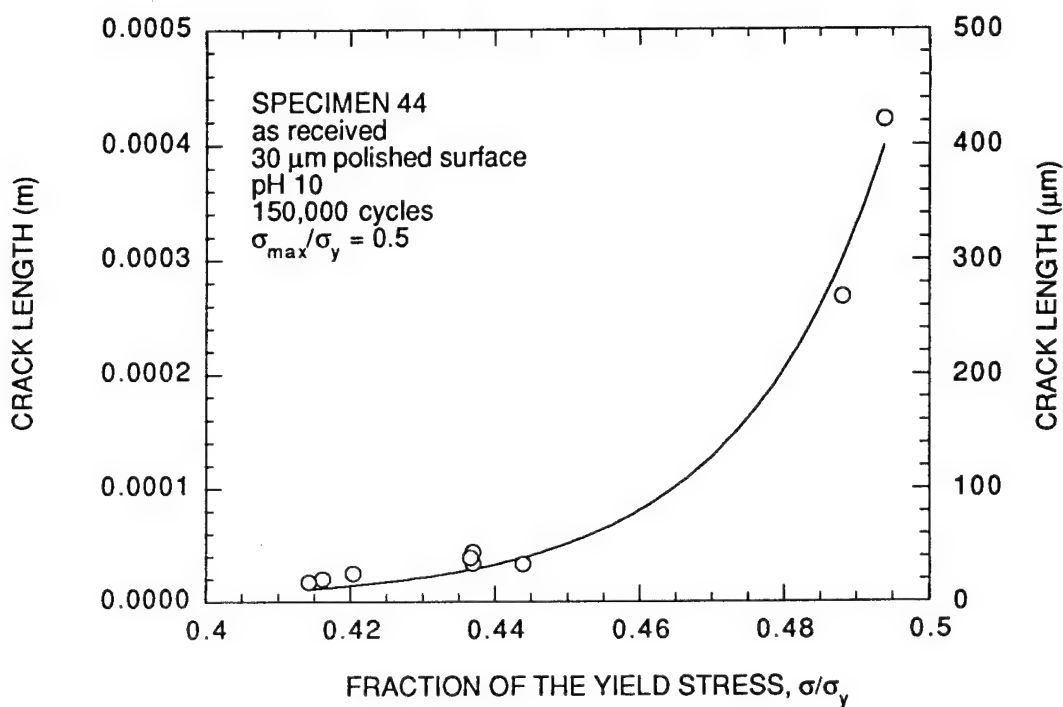
Figure A-29. Crack length data measurements and the least squares fit for Test 44.

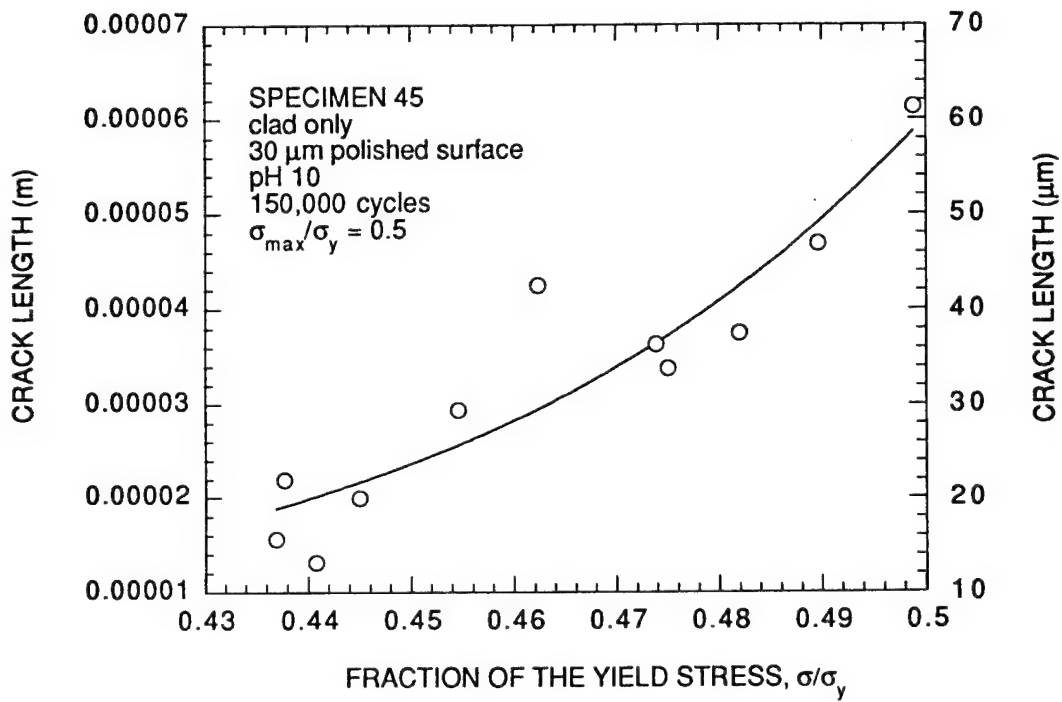
Figure A-30. Crack length data measurements and the least squares fit for Test 45.

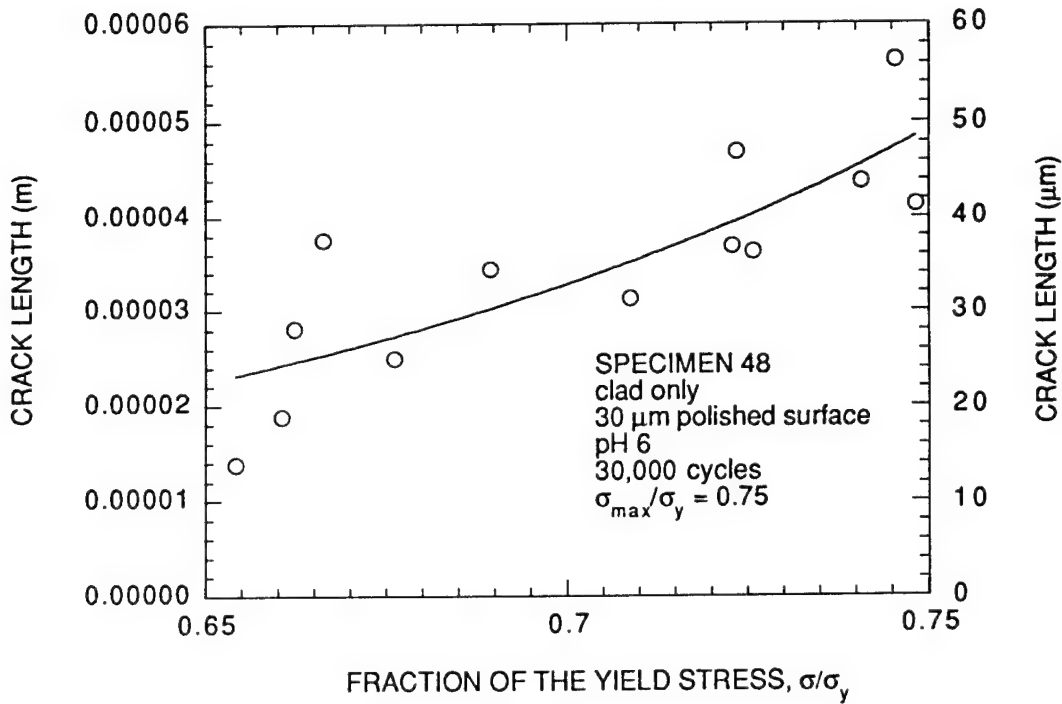
Figure A-31. Crack length data measurements and the least squares fit for Test 48.

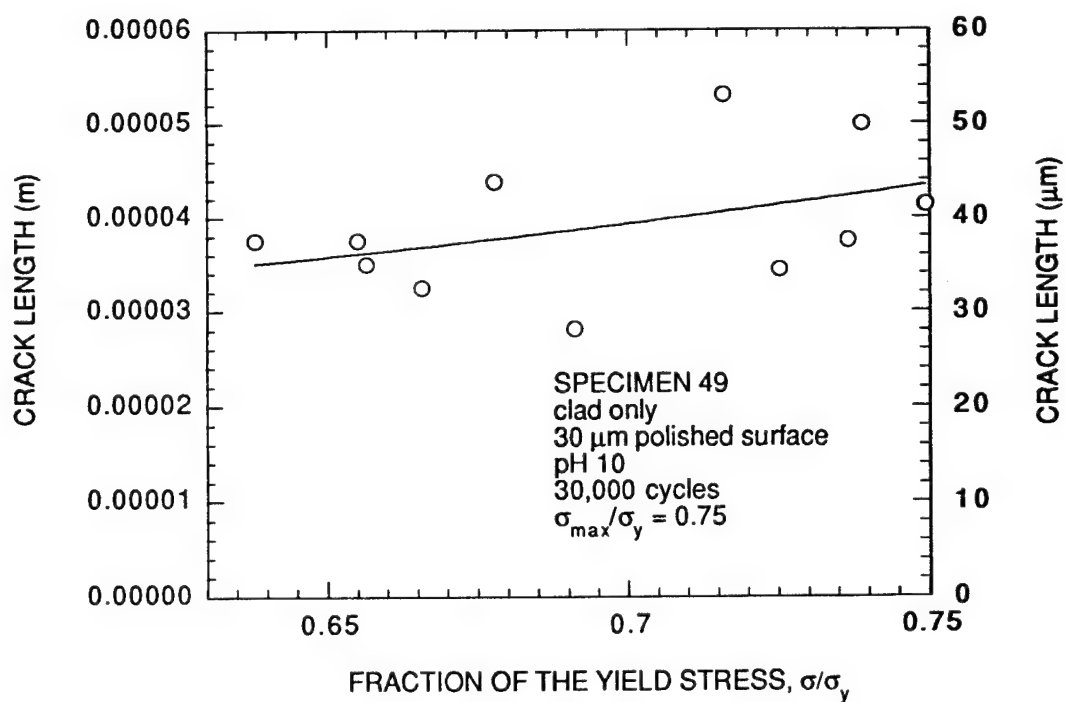
Figure A-32. Crack length data measurements and the least squares fit for Test 49.

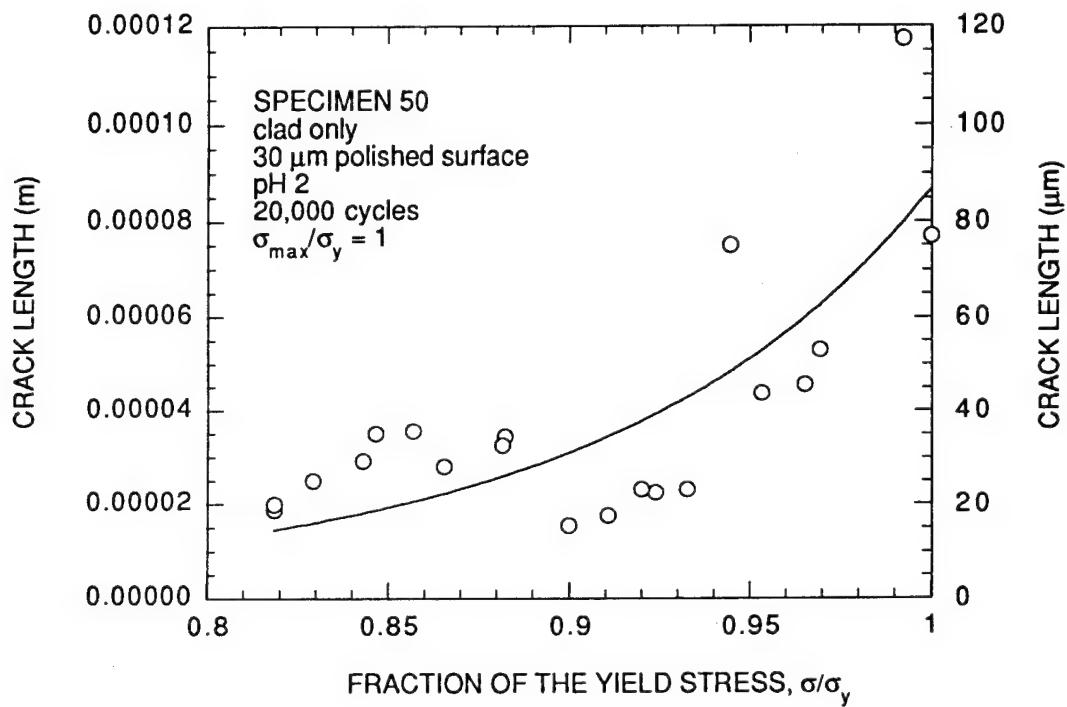
Figure A-33. Crack length data measurements and the least squares fit for Test 50.

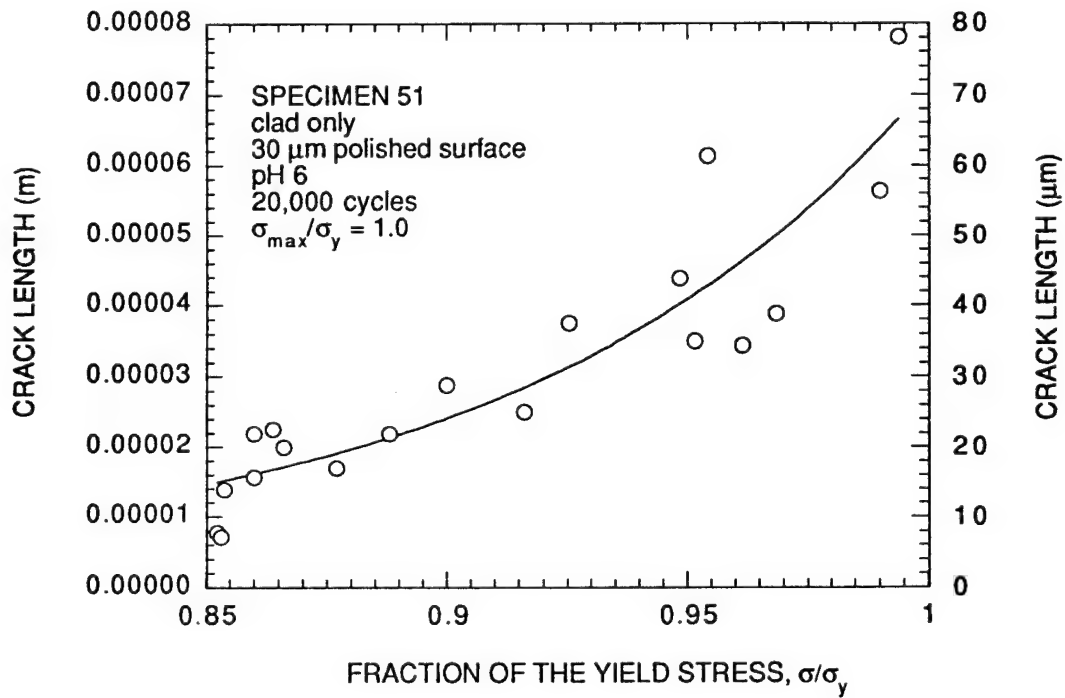
Figure A-34. Crack length data measurements and the least squares fit for Test 51.

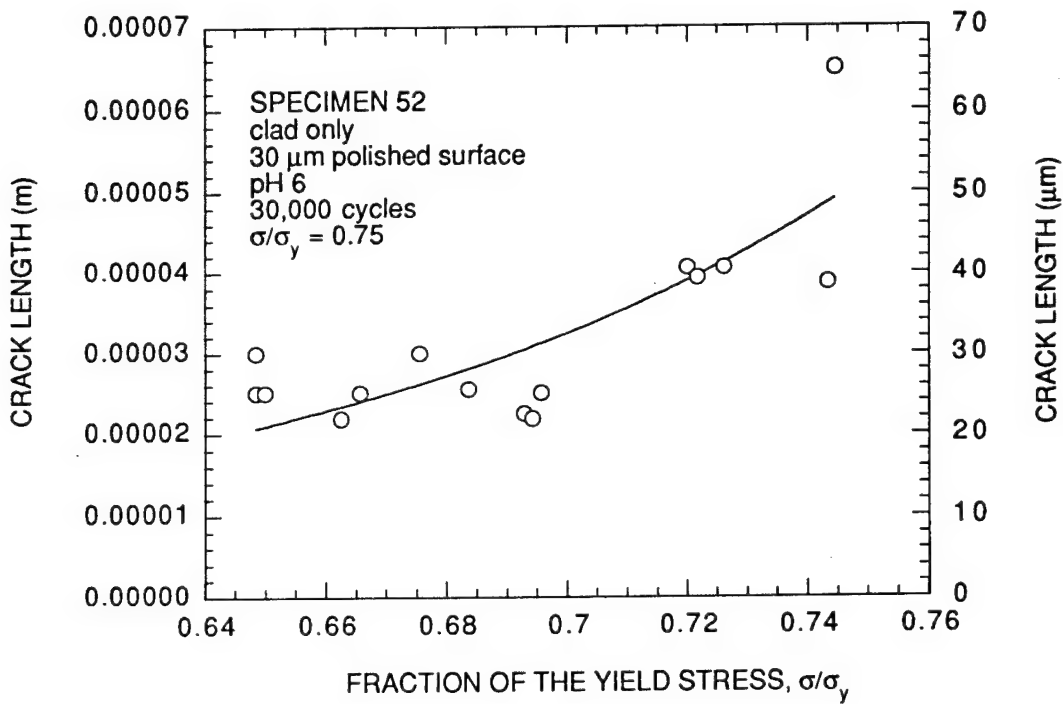
Figure A-35. Crack length data measurements and the least squares fit for Test 52.

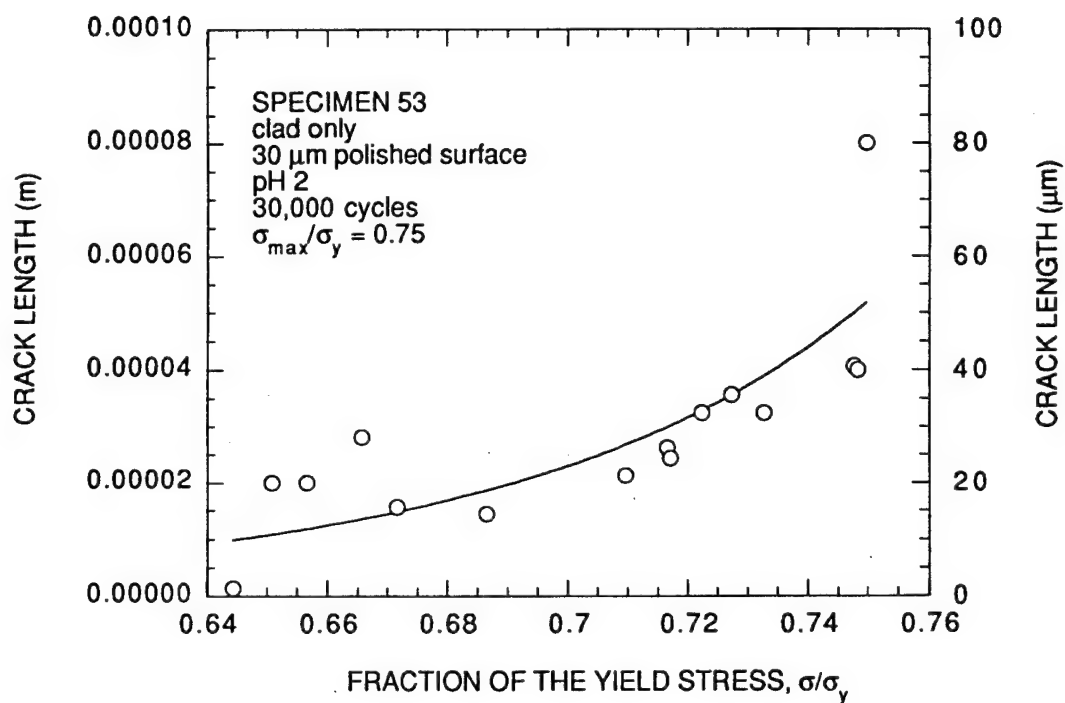
Figure A-36. Crack length data measurements and the least squares fit for Test 53.

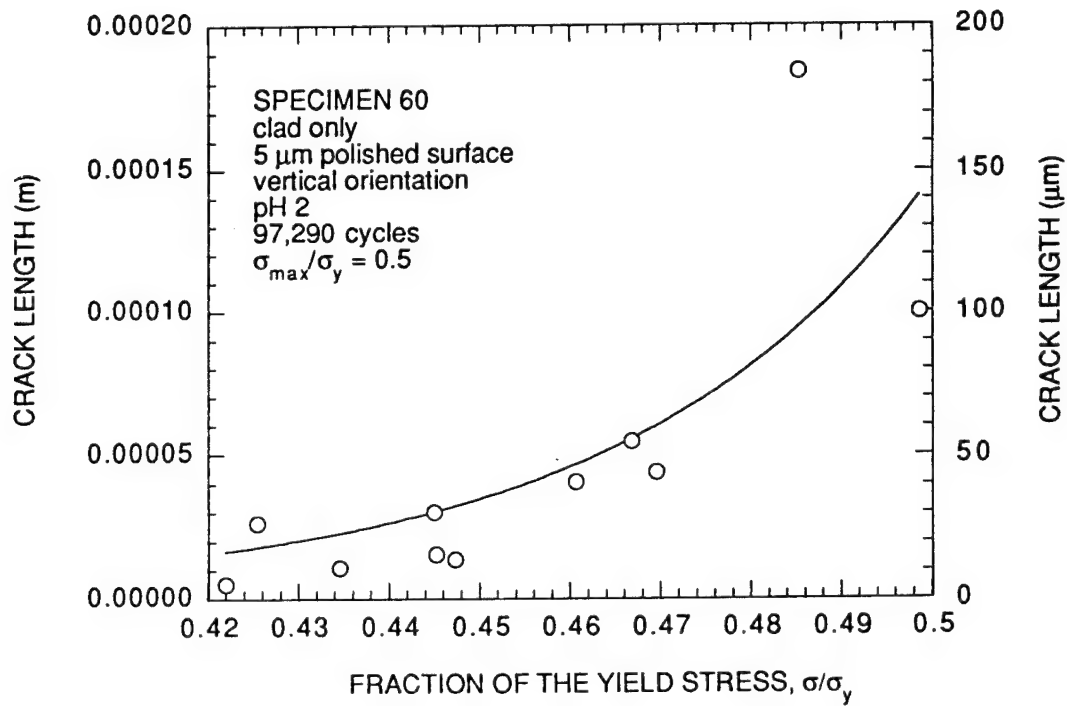
Figure A-37. Crack length data measurements and the least squares fit for Test 60.

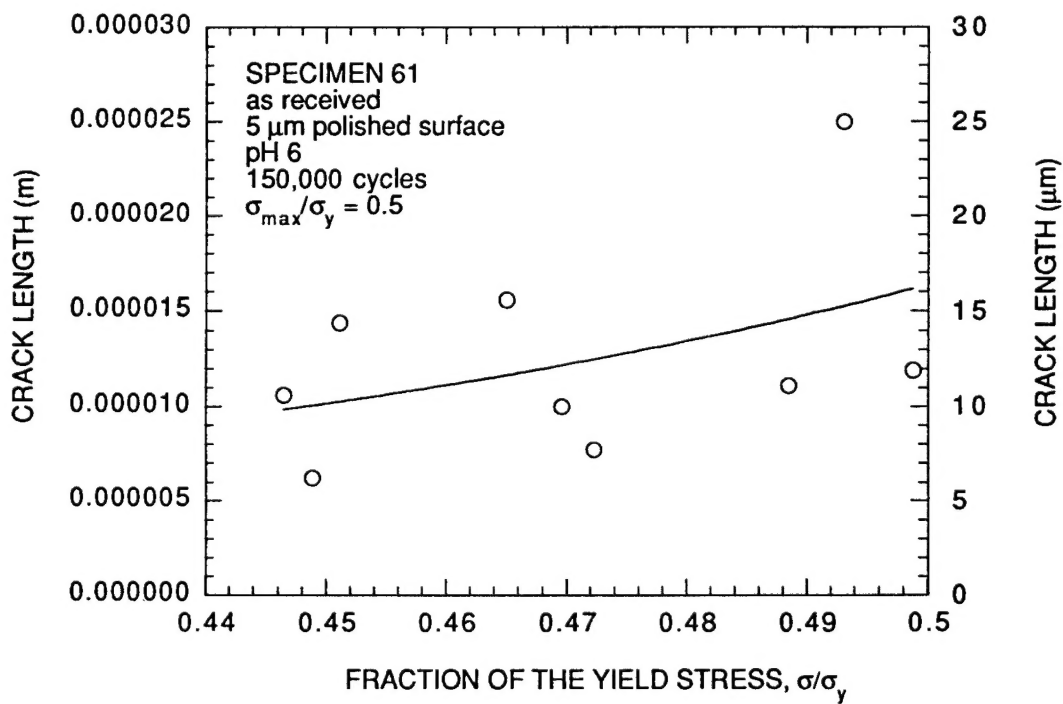
Figure A-38. Crack length data measurements and the least squares fit for Test 61.

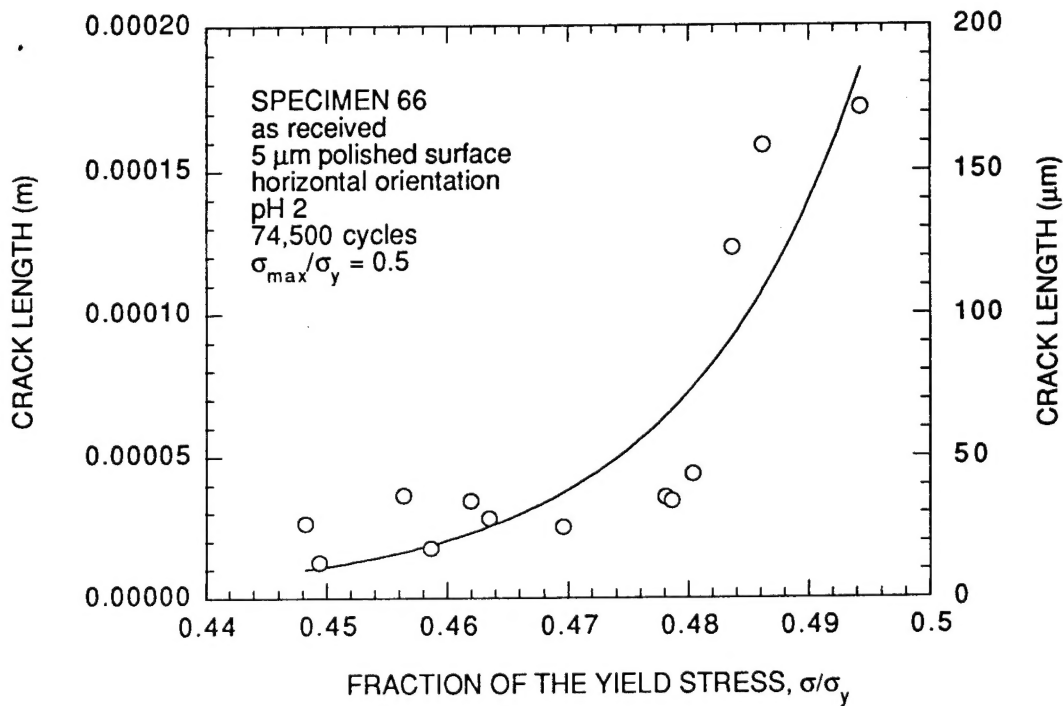
Figure A-39. Crack length data measurements and the least squares fit for Test 66.

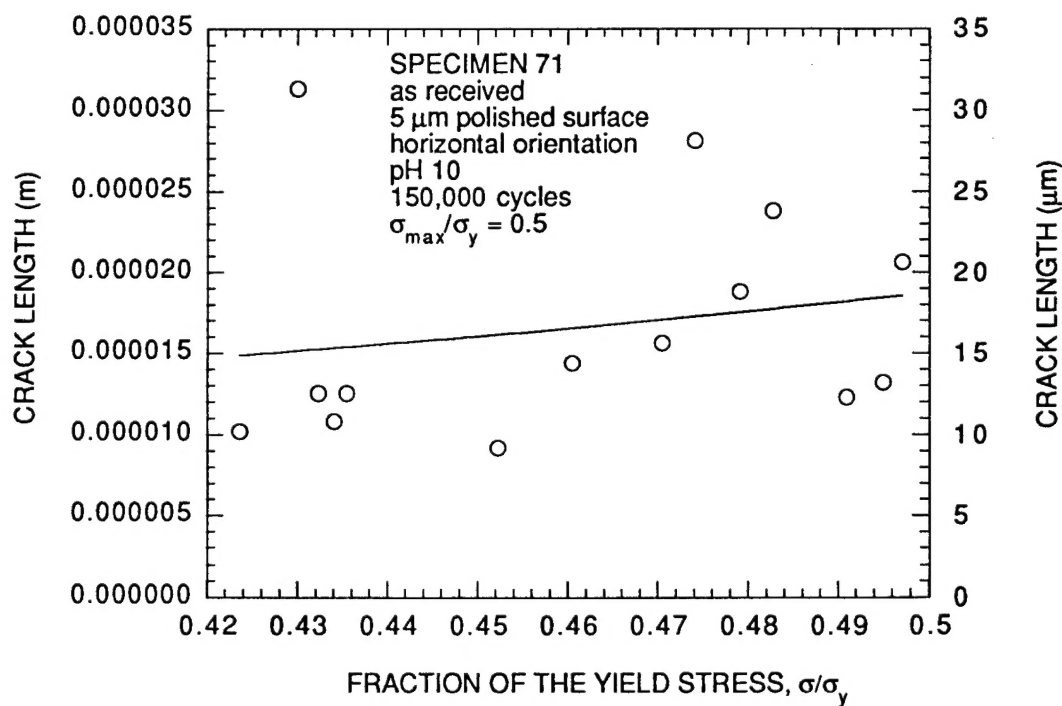
Figure A-40. Crack length data measurements and the least squares fit for Test 71.

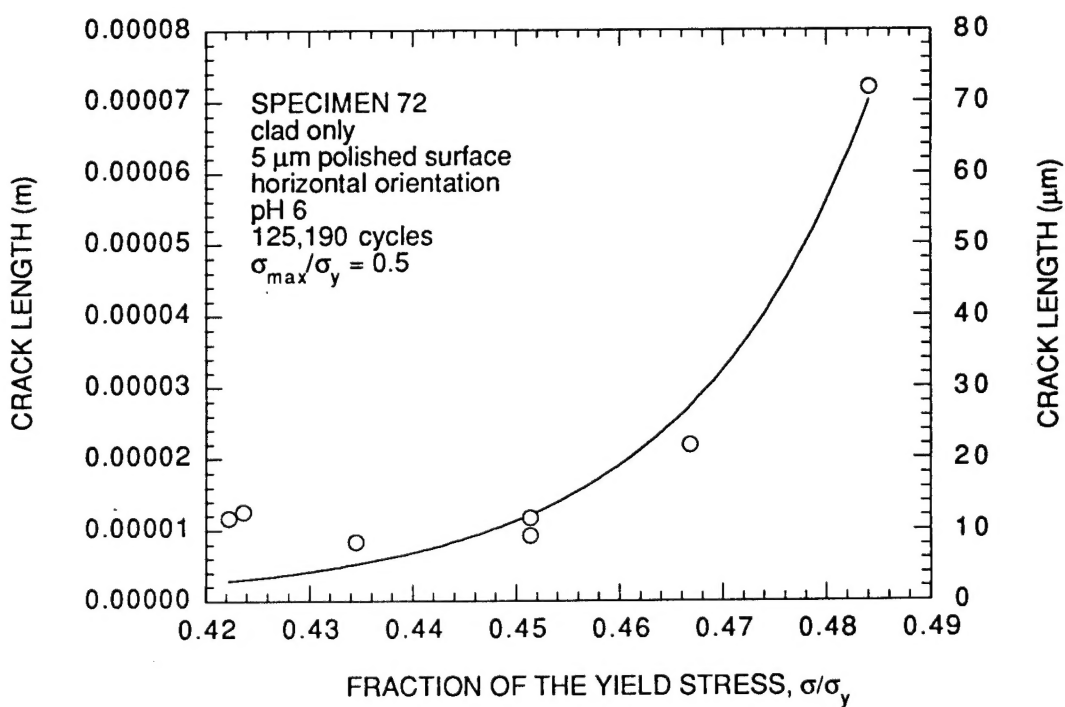
Figure A-41. Crack length data measurements and the least squares fit for Test 72.
